FACILITY COMPLIANCE INSPECTION REPORT

Division of Waste Management Solid Waste Section

Date of Site Inspection: July 16, 2013 **Date of Last Inspection:** July 25, 2012

Waste Industries LLC – LCID Landfill and Wood and Inert Debris Recycling Area
148 Stone Park Court
Durham, NC 27703

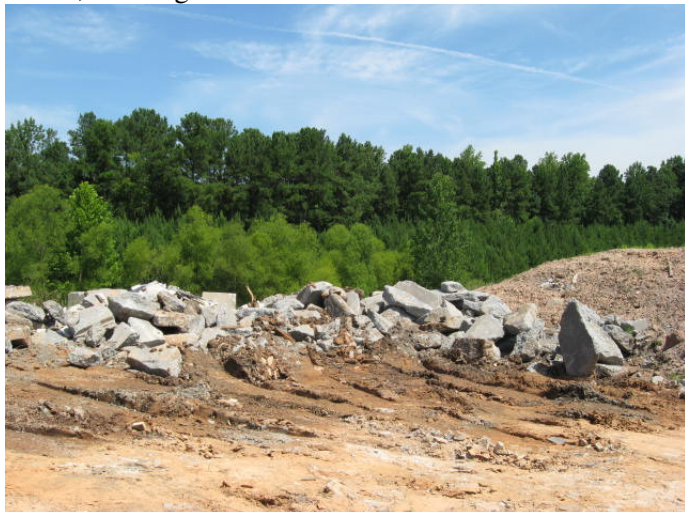
Cell 2, working face

26. Cell 2 is currently active. Ensure unpermitted material is sorted-out.
27. A stockpile of soil is atop a portion of Cells 1 and 2.

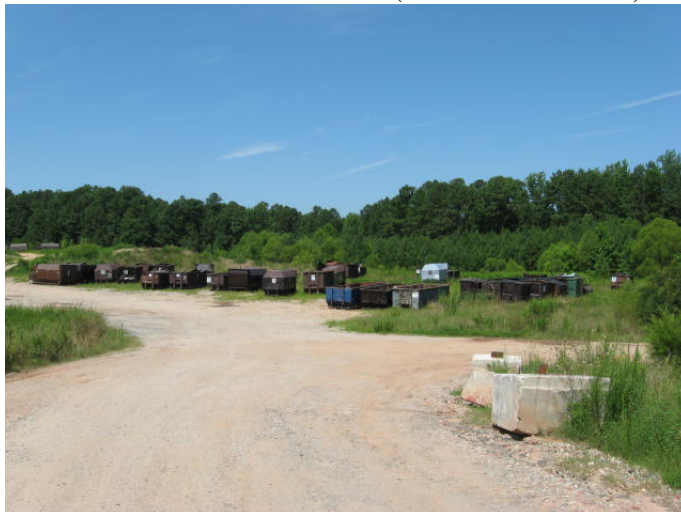
Entrance to LCID landfill area (view of Cells 4 & 5)

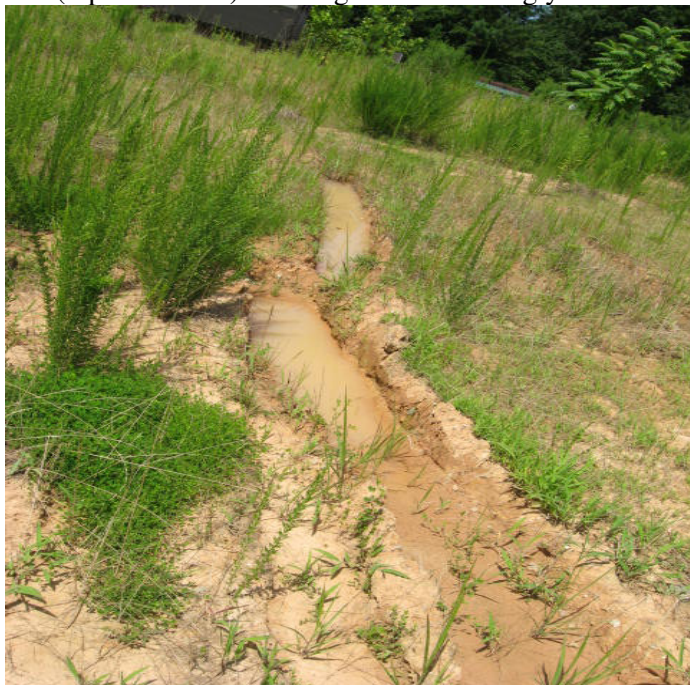
Rut (representative) – to be graded accordingly

21. Ensure that ruts are graded such that they do not hold water.
22. Ensure that edge of waste is \geq 100 feet from wells. Verify if what appeared to be a well is within the buffer area.

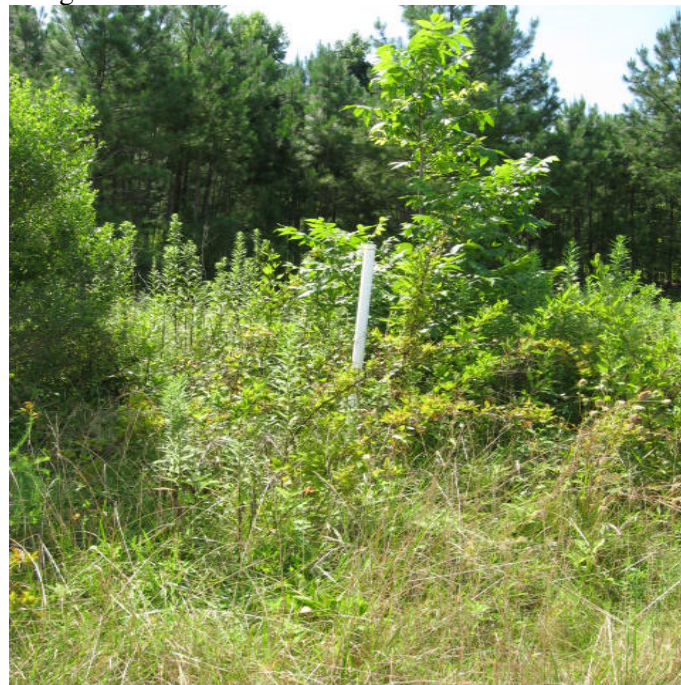
Edge of waste marker

17. The facility has installed edge of waste markers (white PVC tube).
18. It is suggested that vegetation in the permitted landfill area be routinely mowed.
